THE WHEEL DIFFERENCE

In the world of alloy wheel refurbishment if it ain't properly broke, you can probably fix it. We take a look at what's involved.

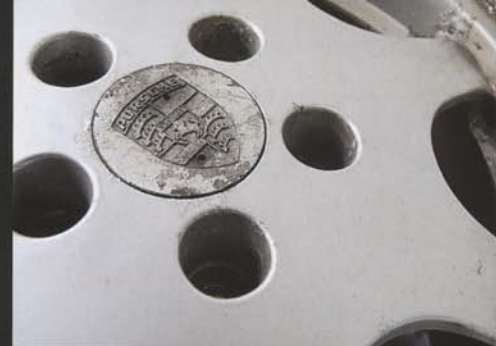
Wheels arrive at Lepsons in all kinds of states, but unless hosed down to bare alloy state. From here kerbing and

Tony's brother and general manager of Lepsons, Andy Leppingwell, explains: "The first thing that has to be done is, obviously, remove the tyre. We then have a facility where up to 60 wheels are soaked in acid to strip their lacquer. After this the wheels are hosed down and moved to the preparation facility."

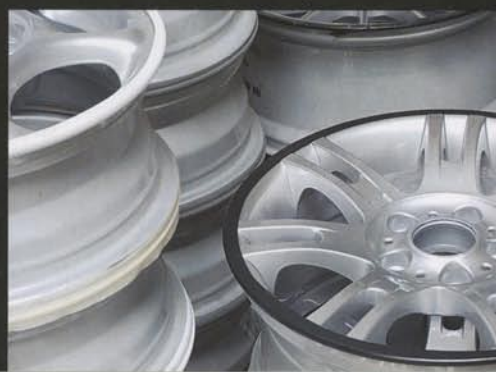
Once back to their original condition in their bare alloy through a process involving a two-stage wash, before

"Once the wheel is back to its pure alloy state we check to make sure it is true, or straight, and then any cracks are built up with metal. This is important to us because it ensures the wheel keeps its original strength. Once any new metal is in, the wheel is sanded down and then finished on the lathe," Tony adds.

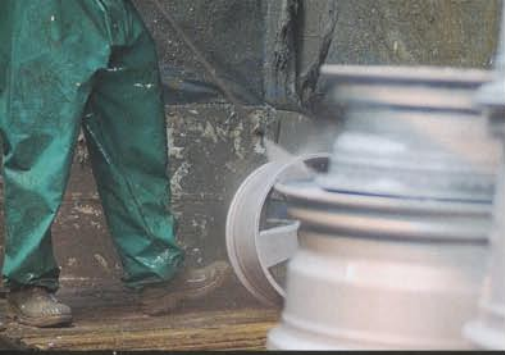
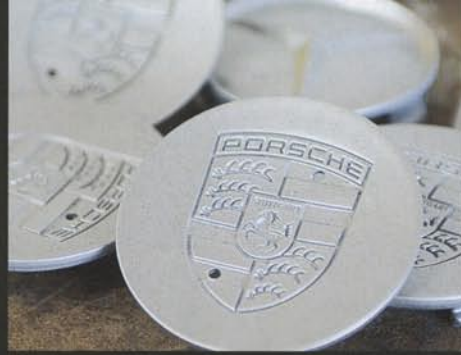
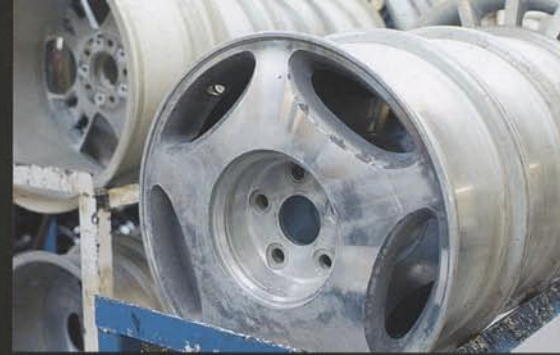
there are big chunks missing or there is major buckling they can usually be repaired. Following an acid bath wheels are other damage can be rectified, before they are sanded down and put on the lathe, ensuring that they are true, or straight

There are of course some wheels that are simply beyond help. Generally speaking these have big chunks missing or are buckled from the centre. Otherwise, whether it is a light kerbing or a flat spot on the back of the rim, the wheel can be brought back to life.

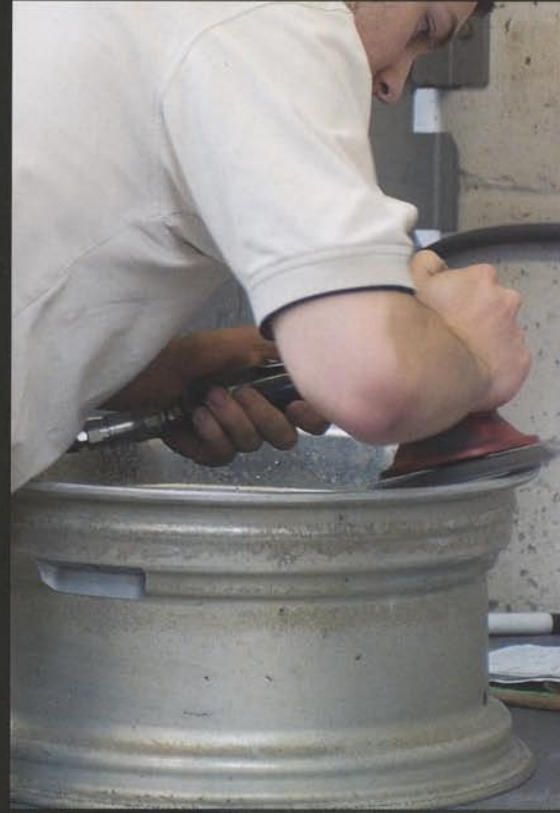
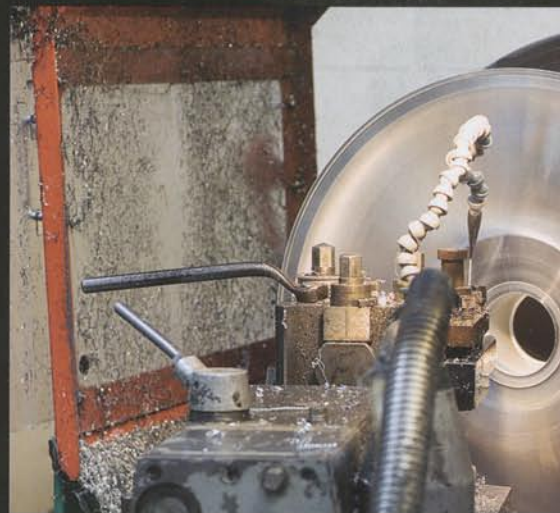
state the wheels enter the painting facility. Here a production line can hold up to 110 wheels at a time, each one passing application of primer, paint and lacquer. Giant ovens bake wheels between stages, while the finished product looks as new

Once back to its original shape the wheel is hung on a production line ready for painting. Up to 110 wheels can be hung from this line, each undergoing the same series of treatments. Firstly, they are cleaned twice more, once with a soap rinse and once with water. They are then warmed in a pre-heat oven before a powdercoat primer is applied. The wheels then return to the oven once again, emerging to be painted either in standard silver or one of the three kinds of silver sparkle offered by Lepsons. After another trip to the oven the lacquer is applied before the wheels are baked for a final time. When completed, the finished item looks brand new.
